BELZONA PROTECTS GAS SEPARATOR FROM PITTING CORROSION

ID: 4505

Customer Location: Natural Gas Plant, South West China
 Application Date: July, 2009

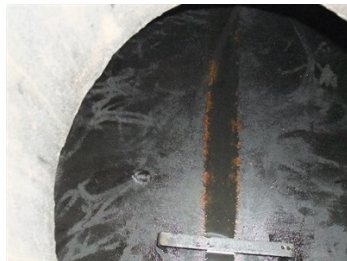
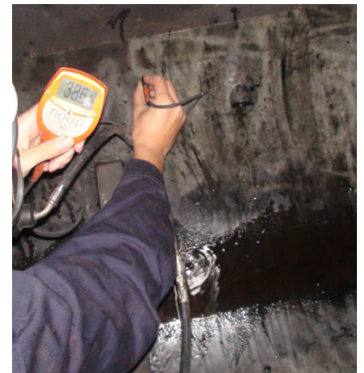
Severe pitting corrosion in the internal wall of the vessel due to presence of sour gas.

- * Internal wall of the vessel before application ,
- * Pitting corrosion in the wall ,
- * Completed application ,
- * Inspection after 6 years ,

The application was carried out in accordance with Belzona Know-How System Leaflets TCC-5. Areas of severe corrosion and pitting were identified and repaired using Belzona 1111 and then coated with Belzona 1321.

By using the Belzona solution, the corroded areas of the separator were repaired and protected from further corrosion. The vessel has been operated with H₂S present for a further 6 years without defects being found.
