BELZONA PROTECTS GAS SEPARATOR FROM PITTING CORROSION

Industry: Oil & Gas
Application: TCC-Tanks and Chemical Containment Areas
Substrate: Carbon Steel
Products: * Belzona 1111 (Super Metal) ,
 * Belzona 1321 (Ceramic S-Metal) ,

Customer Location: Natural Gas Plant, South West China
Application Date: July, 2009

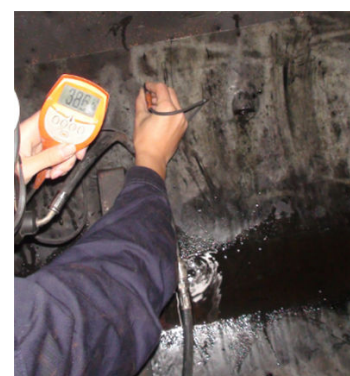
Severe pitting corrosion in the internal wall of the vessel due to presence of sour gas.

- * Internal wall of the vessel before application ,
- * Pitting corrosion in the wall ,
- * Completed application ,
- * Inspection after 6 years ,

The application was carried out in accordance with Belzona Know-How System Leaflets TCC-5. Areas of severe corrosion and pitting were identified and repaired using Belzona 1111 and then coated with Belzona 1321.

By using the Belzona solution, the corroded areas of the separator were repaired and protected from further corrosion. The vessel has been operated with H₂S present for a further 6 years without defects being found.
