PROTECTION OF CHILLER WITH BELZONA CERAMIC METAL SYSTEM

ID: 452

Customer Location: Hotel complex in Egypt
Application Date: May 2004

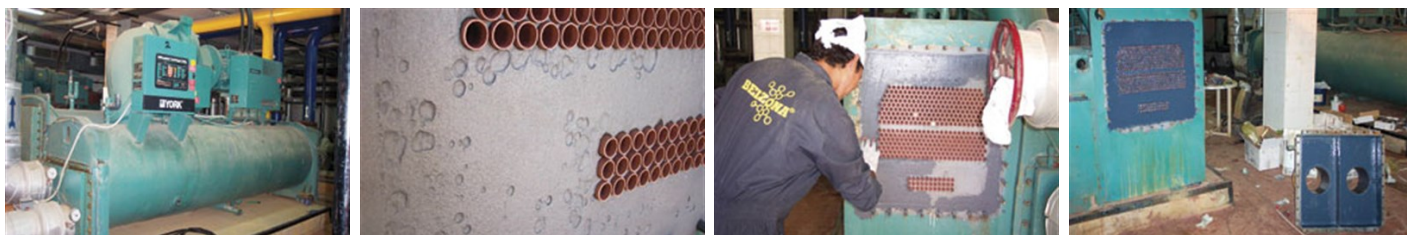
Photograph Descriptions

Corrosion of end covers, water box and tube sheet due to brackish water used for cooling.

- * General view of the chiller ,
- * Degree of corrosion clearly evident ,
- * Corrosion pitting being rebuilt with Belzona® 1311 ,
- * Completed application after application of Belzona® 1321 ,

Application was carried out in accordance with Belzona Know-How System Leaflets HEX-1 and HEX-3.
