# BELZONA FLANGE REPAIR SYSTEM ELIMINATES BLUSHES ON NEW PROCESS VESSEL

ID: 455

Nozzle flange faces on offshore process vessel due for urgent delivery

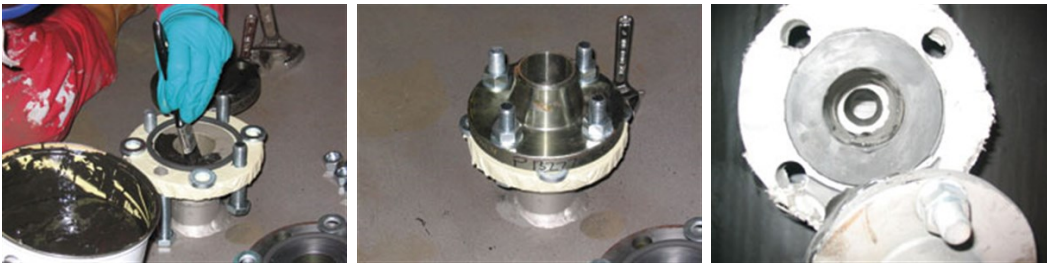
## Photograph Descriptions

*During surface preparation prior to the installation of a Belzona coating, grit blasting damage had occurred to four internal nozzle flange faces. As a result of this the sand recovery system due to be installed could not be fitted.*

- \* Application of Belzona® 1591 to flange face ,
- \* Completed assembly showing former, bolts and shim ,
- \* Finished flange face awaiting removal of masking tape and dressing of internal bore ,

The flange faces were reblasted fully and Belzona® 1591 was installed using a forming process according to Belzona Know-How System Leaflet VPF-13.

Four flange faces were formed using this technique, and were allowed to cure prior to breaking out. Once complete they were protected, the vessel was grit blasted for a second time and Belzona® 1591 applied to the whole vessel. The alternative would have required on-site machining of the flange faces at significant cost.
