BELZONA FLANGE REPAIR SYSTEM SAVES MONEY

Industry: Oil & Gas
Application: VPF-Valves, Pipes and Fittings
Substrate: Galvanised steel.
Products: * Belzona® 1321 (Ceramic S-Metal) ,
* Belzona® 9411 (Release Agent) ,

Customer Location: Offshore Oil Company - UK North Sea
Application Date: November 2003

Flange faces on 16", 300lb crude oil transfer hoses

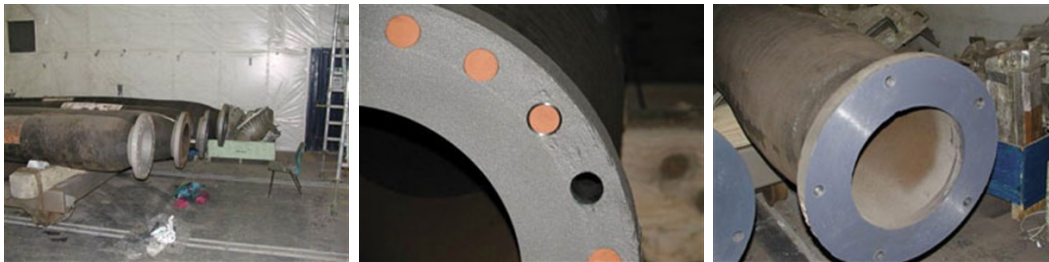
Photograph Descriptions

External corrosion on the flange faces had resulted in the hoses not being able to seal correctly and as a result were considered no longer fit for purpose.

- * Four floating hoses awaiting repair ,
- * Close up showing corrosion damage and plugs and shims fitted into place ,
- * Completed application, awaiting dressing down and pressure testing ,

A procedure based around Belzona Know-How System leaflet VPF-9 was used to reform the flange faces.

The four hoses shown in the picture represent a cost to the customer if replaced of approximately £100,000 (\$160,000). All four hoses were effectively covered and tested to 18 bar according to International (OCIMF 1991) and Dunlop Oil & Marine Test Guidelines. This was done for a fraction of the cost of replacement hoses.
