BELZONA SAVES CRITICAL EQUIPMENT AT ZINC MINE

ID: 4605

Application: *TCC-Tanks and Chemical Containment Areas*

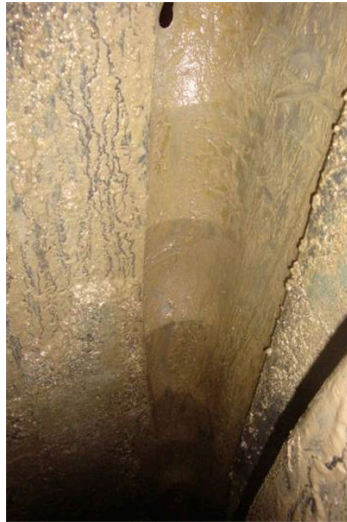
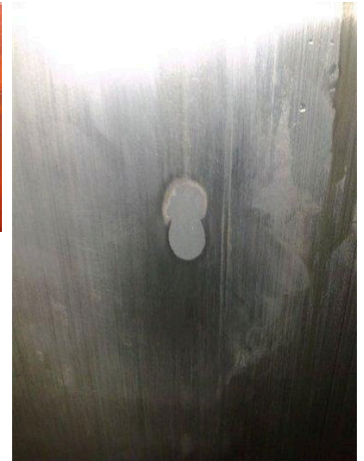
Wear on the riding ring of the primary ore mill resulted in the development of a hole. This allowed leakage of slurry into the mill gearbox lubrication system. As this was a single stream mill, this was a critical piece of equipment and needed to be returned to service immediately.

* Aerial view of the Zinc mine Initial view of the damaged area Damaged area following cleaning Belzona 1111 repair 3 years later

Belzona 1111 Super Metal was applied in accordance with a modified version of Belzona Know-How System Leaflet TCC-5

Belzona 1111 quickly sealed the leaking areas, preventing further contamination and allowed the critical part to return to service faster than conventional repair techniques, saving the customer in downtime and resulting production losses. After three years the repaired area was inspected and is still in perfect condition.
