BELZONA SOLUTIONS FOR LEAKS

ID: 462

Customer Location: Animal food manufacturing - Missouri, USA

Application: VPF-Valves, Pipes and Fittings

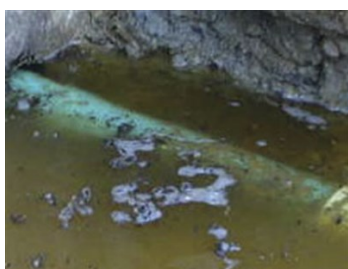
Filler used between the drain pipe and the wall when constructed was allowing water to seep through the one inch gap around the pipe and collect underground. A \$10,000 fine from environmental concerns was on the horizon.

- * Visible leak ,
- * Leak sealing with Belzona® 4211 in process ,
- * External heat was applied to decrease curing time and ensure the area was dry ,
- * Finishing the application ,
