# BOW THRUSTER PROTECTION WITH BELZONA

ID: 4645

Industry: *Marine*  
Application: *SOS-Ships and Offshore Structures*

Customer Location: *Dockyard, Montenegro*  
Application Date: *November, 2008*

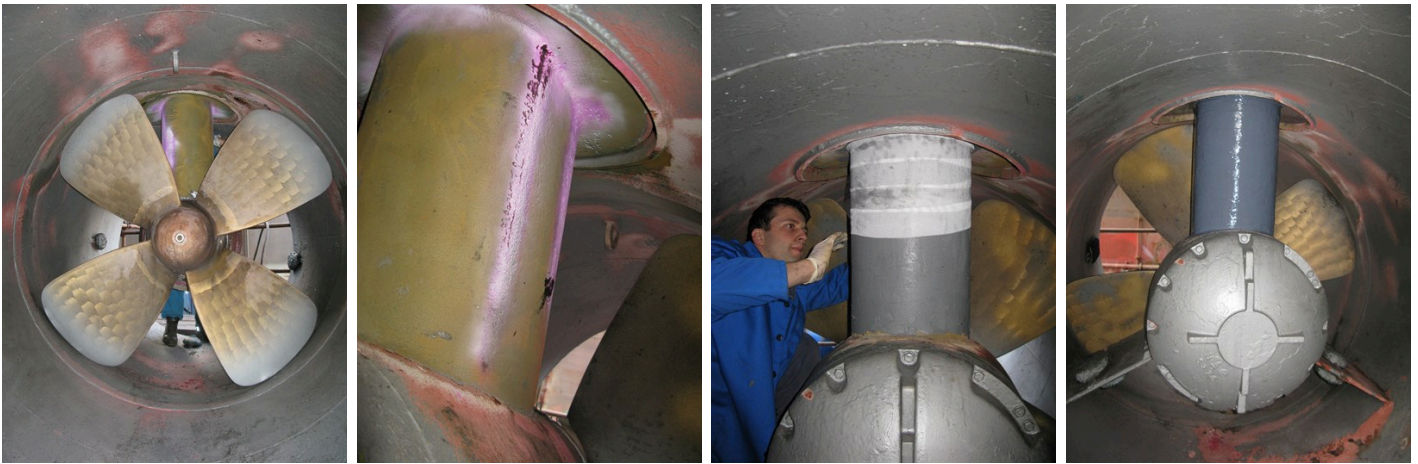
*Pitting damage caused by erosion/corrosion to the bow thruster.*

- \* Bow thruster ,
- \* Pitting damage clearly evident ,
- \* Reinforcing Tape being combined with Belzona 1311 ,
- \* Belzona 1321 protective coating applied to complete the job ,

Bow thruster on cargo vessel

Application was carried out in accordance with Belzona Know-How System Leaflets SOS-1 and 2.

Belzona's excellent time saving renewal and protection method was a fraction the cost compared to replacement and dry-dock time consuming alternative. Restoration with Belzona was done in 48 hours, resulting in long term erosion/corrosion protection.
