INSPECTION PIT SAFETY IMPROVED WITH BELZONA

ID: 466

Customer Location: Military installation - UK
Application Date: July 2002

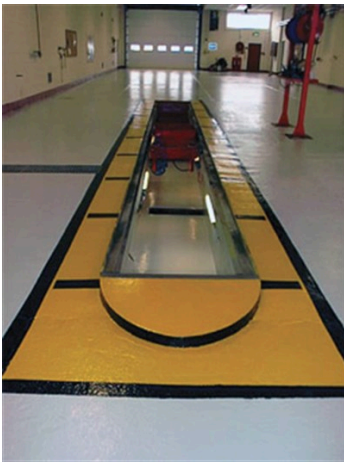
- * Overview of the inspection pit, following application. ,
- * Belzona systems improve safety on steps too. ,

After scabbling the concrete and planing rough areas a two-coat system of Belzona® 5231 was applied to the workshop floor and inspection pit. An additional strip of Belzona® 4411 grip system was applied to step nosings to provide additional grip and safety.
