# BELZONA SAVES REFINERY FROM DAILY LOSSES OF £1.5M

ID: 4661

Customer Location: Petrochemical Refinery, UK  
Application Date: June 2013

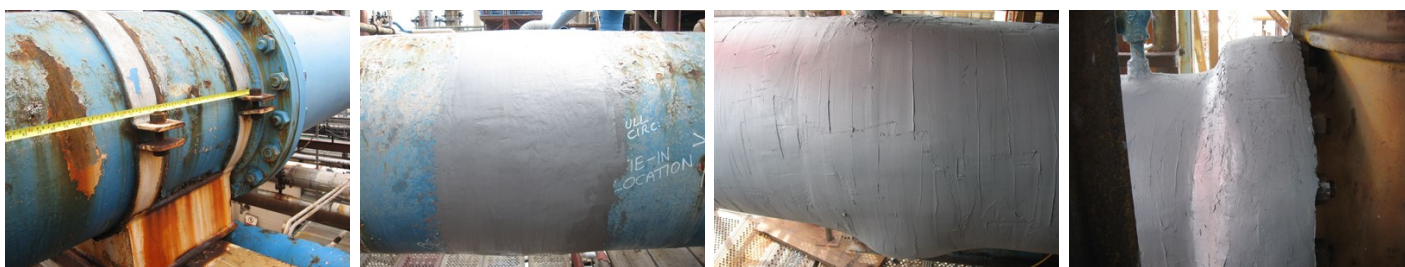
Severe external corrosion had reduced wall thickness. The client required a fast solution to this problem with minimal service disruption. After all, every day of shutdown was costing them £1.5 million.

- \* Corroded and pitted pipework ,
- \* Temporary wrap over holed area ,
- \* Application of chemical resistant wrap ,
- \* Final wrap and flange encapsulation ,

The application was carried out in accordance with Belzona Know-How System Leaflet VPF-11. The application team worked on live equipment, hence shutdown was not necessary. Where leaks were present, a plate was bonded using Belzona 1221 over a holed area. A temporary wrap was created around that area using the same material. Then the whole pipe was wrapped using Belzona 4301. Belzona 1161 wrap was applied on top and also used to encapsulate the adjacent flange.

would initially meet Belzona 4301, which has excellent acid resistance. Belzona 1161 in turn adds mechanical strength, while at the same time protecting the pipework from external damage. The Belzona solution was applied online, hence a shutdown estimated to cost the refinery £1.5M/day was not required. The application only took 3 days to complete.
