COLD APPLIED BELZONA VESSEL LININGS TAKE THE HEAT

Industry: Oil & Gas
 Application: TCC-Tanks and Chemical Containment Areas
 Substrate: Steel
 Products: * Belzona 1591 (Ceramic XHT Metal) ,
 * Belzona 1511 (Super HT-Metal) ,

Customer Location: FPSO, Brazil
 Application Date: September, 2009

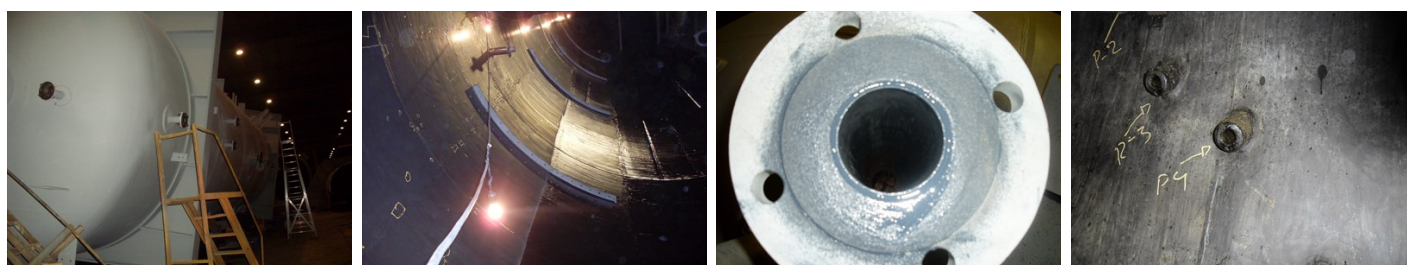
Photograph Descriptions

* 1. Vessel, outer view 2. Lining application 3. Flange face sealed and nozzle insert installed 4. Inspection in 2013 ,

Application was carried out in accordance with Belzona Know-How System Leaflets - TCC-5 for protecting and rebuilding steelwork, TCC-16b for protecting the small bore nozzles and VPF-13 for sealing and repairing the flange faces.

Belzona system was chosen due to its excellent heat resistance properties and proven longevity. The work was carried out in September 2009 and in February 2013 one of the desalters was opened for inspection. The condition was described as “flawless”. The lining, flange faces and small bore nozzles all showed no signs of deterioration.
