BELZONA COATS A SHOWER FLOOR AND PREVENTS MAJOR WATER ISSUES

ID: 4663

Communal shower floors at an Army Base

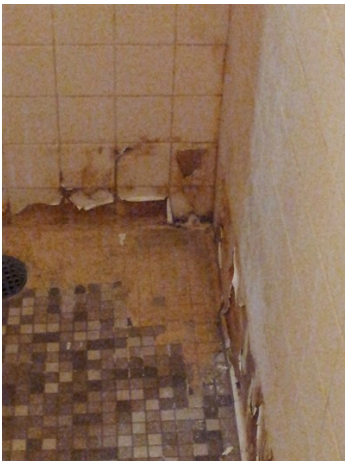
Remove existing coating. Seal Floor from leaking water. Repair damaged tiles, and missing tiles. Provide a non-slip surface. Make cosmetically appealing. Ensure easy cleaning. Provide lasting wear-resistance and protection from further damage. The grout between the tiles has been removed over time due to heavy cleaning with bristle brushes, therefore allowing water to bleed through the walls and onto the public walkways, causing a slip hazard and water damage to the dividing walls. After several attempts of regrouting, the customer tried installing a truck liner product to seal the floor. Shortly thereafter, the coating peeled off and created a cosmetic mess and made it difficult to clean. When trying to remove the failed truck liner, several tiles broke and cracked, causing more water issues.

- * Existing Conditions ,
- * Grouting with Belzona 4111 ,
- * First coat of Belzona 5811 encapsulated with Belzona 9221 ,
- * Application completed with a second coat of Belzona 5811 ,
