BELZONA REPAIR TO LOADER TYRE SIDEWALL

ID: 4669

Industry: Mining & Quarrying
Application: SHM-Solids Handling Machinery

Customer Location: Quarry in Croatia
Application Date: April, 2013.

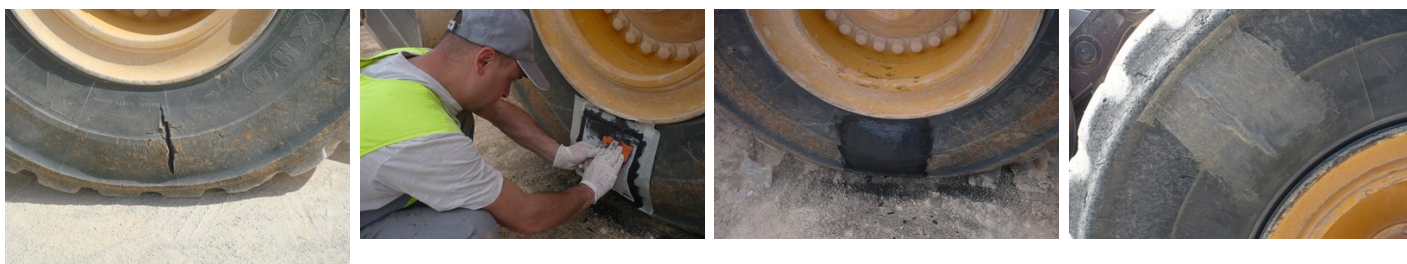
Photograph Descriptions

There was a large crack in a tyre, but it was not leaking and the steel reinforcement was still in good shape. Customer needed to keep the loader in operation.

- * Damaged tyre on wheel loader ,
- * Application in progress ,
- * Application finished ,
- * Site revisited after 3 months, the tyre is still in perfect shape ,

Application was carried out in accordance with Belzona Know-How System Leaflet SHM-9.

The two alternatives were either to replace the tyre or to dismantle it and transport it to the nearest workshop. Belzona repair was carried out during the weekend and customer didn't lose any production time. The Belzona repair prevented further deterioration of the tyre and was performing well when expected three months later.
