BELZONA REPAIRS HYDROCARBON TRANSFER LINES ONLINE

Industry: Chemical & Petrochemical
Application: VPF-Valves, Pipes and Fittings
Substrate: Steel
Products: * Belzona® SuperWrap ,

Customer Location: Fuel storage depot, Italy
Application Date: June 2013

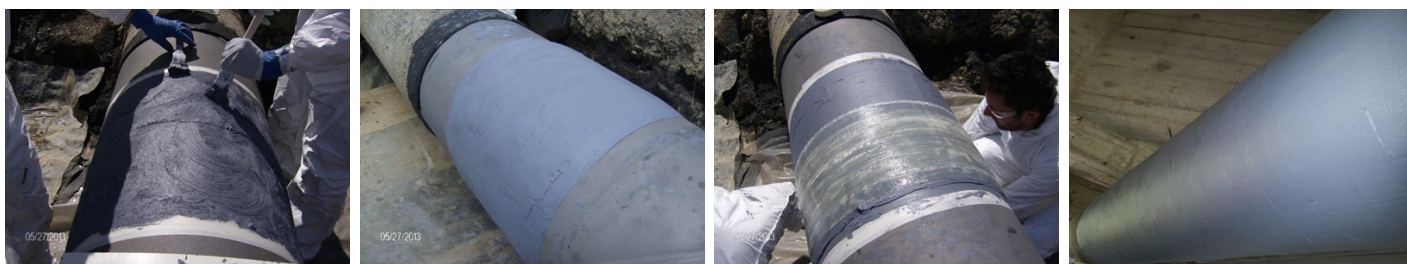
Photograph Descriptions

The pipelines were suffering from external corrosion, which had led to thin walls with minimum thickness in some places reaching 1.4mm, whereas the original wall thickness was 9.52mm. The client required a composite repair compliant to ISO/TS 2481 that could be completed on both pipes within a limited timeframe and without the need for shutdown.

- * 1. Wetting out the substrate 2. Rebuilding corrosion pitting 3. Applying the fibre/resin composite 4 Completed application

Belzona's fully compliant SuperWrap system was chosen and designed to Belzona's most stringent standards. The hydrocarbon pipe required two layers of material, whereas the oil transfer pipe was encapsulated using five layers. Application took place in June 2013 and the client was so satisfied with the outcome, they ordered similar repairs to be carried out on the rest of the exposed pipework in the following months. The expected service life of this application is a minimum of 10 years, which could be extended during a 2023 inspection.
