BELZONA® PROVIDES LONG-TERM PERFORMANCE IN BRIDGE JOINTS

ID: 4672

Industry: *Buildings & Structures*
Application: *FPA-Floor Problem Areas*
Substrate: *Concrete and steel*
Products: ** Belzona® 4521 (Magma-Flex Fluid) ,*

Customer Location: *Department of Transportation, USA*
Application Date: *2005*

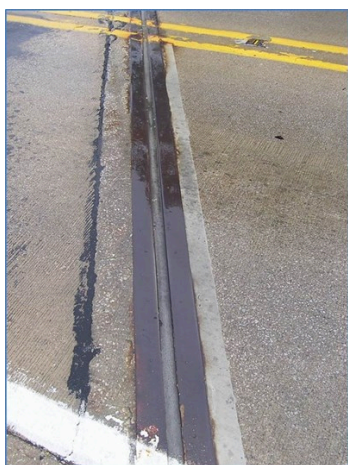
- * Application of Belzona® 4521 between the armor plates ,
- * The intentional pinhole in the bay beneath Belzona application remains unchanged after 5-year service ,
- * The bays on the east end of the bridge beneath Belzona application shows no signs of leakage after 5-year service ,

Application was carried out in accordance with the Belzona Know-How System Leaflet FPA-6 using approximately 200 cu in of Belzona® 4521.

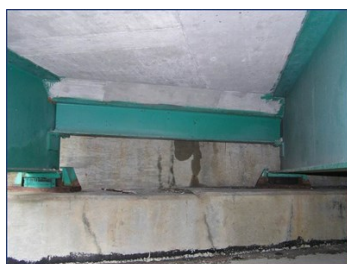
was reviewed and showed no signs of leakage after several hours of hard rain. An intentional pinhole was added during installation to test failure resistance. Pinhole also remained unchanged after 5 years. A conventional silicone joint material installed on the other part of the bridge began leaking within 12 months of being placed.

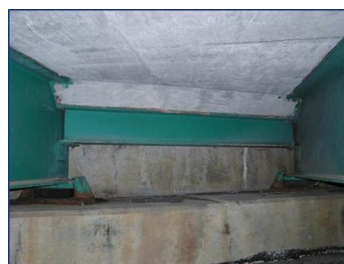
Belzona solution has a long successful history providing long term performance. After 5 years in service, Belzona® 4521 application
