BELZONA® PROVIDES LONG-TERM PERFORMANCE IN BRIDGE JOINTS

ID: 4672

Problem

Joints needed to be sealed between existing armor plates on the bridge

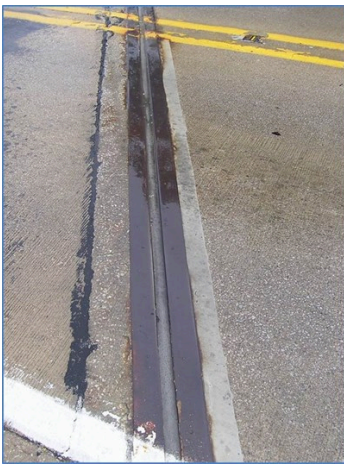
- * Application of Belzona® 4521 between the armor plates ,
- * The intentional pinhole in the bay beneath Belzona application remains unchanged after 5-year service ,
- * The bays on the east end of the bridge beneath Belzona application shows no signs of leakage after 5-year service ,

Application was carried out in accordance with the Belzona Know-How System Leaflet FPA-6 using approximately 200 cu in of Belzona® 4521.
