BELZONA REPLACES MECHANICAL MOVEMENT JOINTS

ID: 4679

Customer Location: Hospital, Newcastle Upon Tyne, UK
Application Date: September, 2013

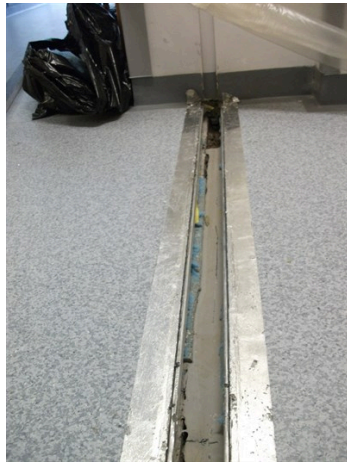
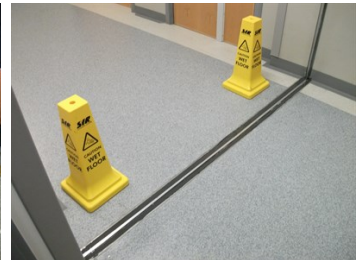
The new building was built approx. 3 years ago and mechanical movement joints were installed throughout the building. Over the 3 year period there has been a lot of movement within the building resulting in the gap on the joints increasing to the extent that they are now failing and allowing cleaning detergents to by-pass the sealing "O" Rings on the joints and to leak into the rooms below, some of which are operating theatres.

- * Diagram of the original mechanical joint ,
- * Sliding components of expansion joint removed ,
- * Aluminium spacer bar being fitted in centre of the joint ,
- * Finished expansion joint ,

Application was carried out in accordance with Belzona System leaflet FPA-6. The existing sliding components of the joint were removed from the fixed shoulder of the joint. These were prepared using the MBX Bristle Blaster. The 2 edges of an aluminium spacer bar (19mm W x 38mm H) were also prepared. After centering the spacer bar the Belzona 2221 system was applied to either

side of the spacer bar to create a sealed expansion joint.
