# Transformer bushing leak sealed with Belzona

ID: 4682

Industry: Power  
Application: MPT-Mechanical Power Transmission

Customer Location: Glasgow, Scotland  
Application Date: September 2013

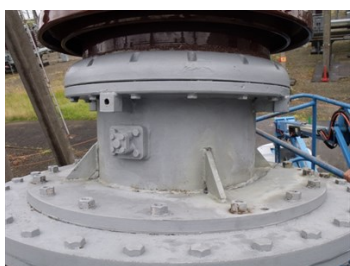
- \* 1. Bushing before. ,
- \* 2. Struts before application showing crack. ,
- \* 3. Transformer after overcoating with Belzona 5831 ,
- \* 4. Plate bond after overcoating with Belzona 5831 ,

Two 19 inch diameter bushings on a transformer were leaking oil. The leaks were coming from cracks in four steel support struts.

The repair was carried out in accordance with an adapted version of Belzona system Leaflet SOS\_1. The leaks were first stemmed using Belzona 9611. Pre blasted plates were then bonded into place around the struts using Belzona 1161, the purpose of these plates was to give the structure back some strength so the cracks in the steel would not propagate. The repairs were then protected with Belzona 5831.
