RUBBER TRACKS ON MOBILE DRILLING RIG QUICKLY REPAIRED WITH BELZONA

ID: 4683

Industry: General Industry
Application: SHM-Solids Handling Machinery

Customer Location: Geotechnical survey company, Croatia
Application Date: September, 2013.

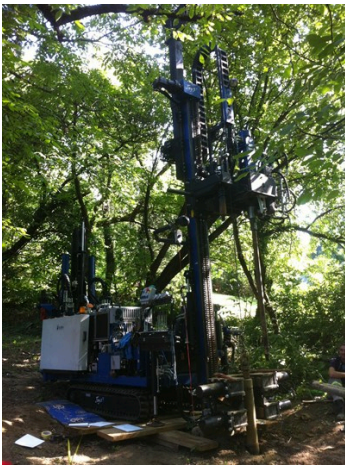
- * Geo drilling machine on site ,
- * One of the damaged areas on the tracks ,
- * Damaged area after surface preparation and Conditioning ,
- * Application finished. ,

Mobile Geotechnical drilling machine operating two shifts per day.

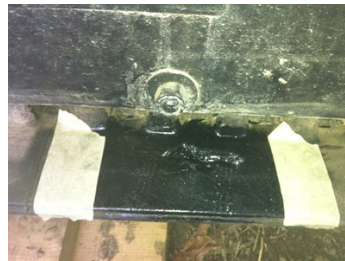
Several damaged areas on its rubberized tracks required quick repair to prevent track failure.

The application was carried out in accordance with Belzona System Leaflet SHM-1.
