# BELZONA SEALS LEAKING BALCONY ROOF AT WORLD FAMOUS COLLEGE

ID: 4689

**Customer Location:** College, Cambridge, UK  
**Application Date:** August 2013

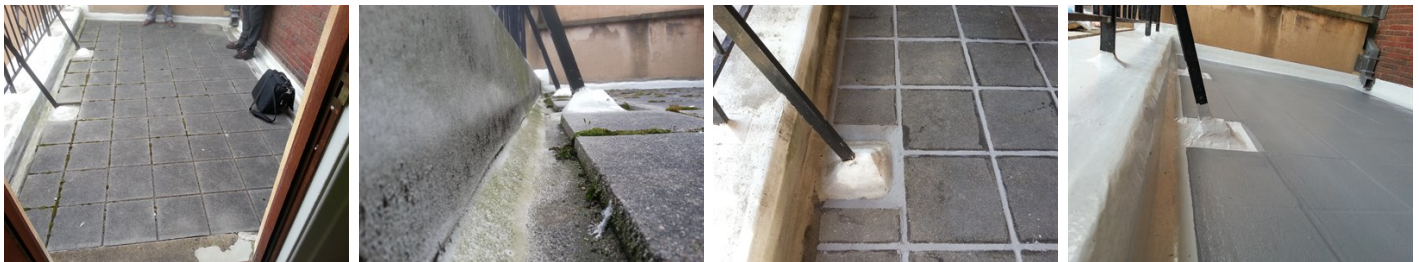
The asphalt roof was leaking underneath the concrete slabs, causing water damage to the rooms below. To repair the roof the College was planning to remove the concrete slabs, replace the asphalt roof and then reinstall the concrete slabs.

- \* Leaking balcony roof with paving slabs ,
- \* Close up of paving slab edge ,
- \* Gaps between slabs filled with Belzona® 4131 ,
- \* Balcony roof coated with Belzona® 3131 system with 3rd coat incorporating Belzona® 9231 aggregate anti-slip system ,

Application was carried out in accordance with Belzona Know-How System Leaflet RPA-6. The gaps between all paving slabs were cleaned and filled with Belzona 4131. A fully reinforced Belzona® 3131 system was then applied to weatherproof the area. This was followed by a further coat of Belzona® 3131 blinded with Belzona 9231 aggregate to create a non-slip walkway.
