# QUICK AND EASY DOOR REPAIR WITH BELZONA

Industry: Buildings & Structures  
Application: WPA-Wall Problem Areas  
Substrate: Wood  
Products: \* Belzona® 8111 (Mouldable Wood) ,

Customer Location: Housing Association, Worcester, UK  
Application Date: September 2013

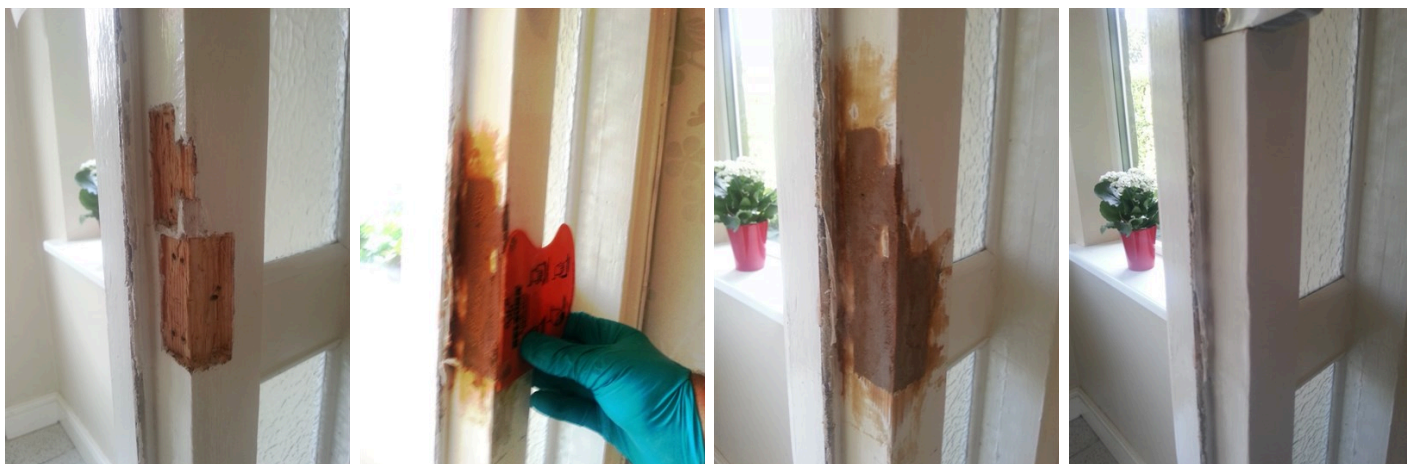
A new door had been fitted with a new lock and catch. The position of these had to be changed leaving two cut outs in the door frame from the old lock and separate catch.

- \* Damaged door frame ,
- \* Applying Belzona® 8111 ,
- \* Completed wood repair ,
- \* Painted finish ,

Application was carried out in accordance with Belzona Know-How System Leaflet WPA-5. A Belzona plastic applicator was used both to apply the product and as a former to create the required profile.

The repair was carried out in less than one hour from start to finish and in one site visit. The alternative repair for the Housing Association had been replacing door frames. Far more costly and time consuming.
