BELZONA RESTORES BED ON A PRESS BRAKE

ID: 4693

LVD Pressbrake used to bend sheet metal

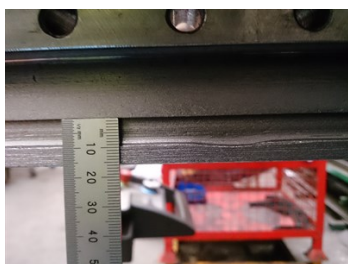
The locating bed on the press had worn over time due to sliding different shaping tools into place. This was leading to the shaping tools sitting at an angle and producing inaccurate results.

- * Damaged area after surface preparation ,
- * Area to be rebuilt ,
- * Forming plates being held into place ,
- * Completed application ,

Application was carried out in accordance with Belzona System Leaflet GSS-8. Forming boards were made and coated with Belzona 9411 (Release Agent). They were then held in place along the length of the press. Belzona 1121 was injected to the require depth. Once cured the formers were removed revealing the new surface.
