# BELZONA 'RUBS' TUGBOAT THE RIGHT WAY

Customer Location: *Crowley Marine, Long Beach, California, U.S.A.*

Application: *SOS-Ships and Offshore Structures*

Substrate: *Rubber*

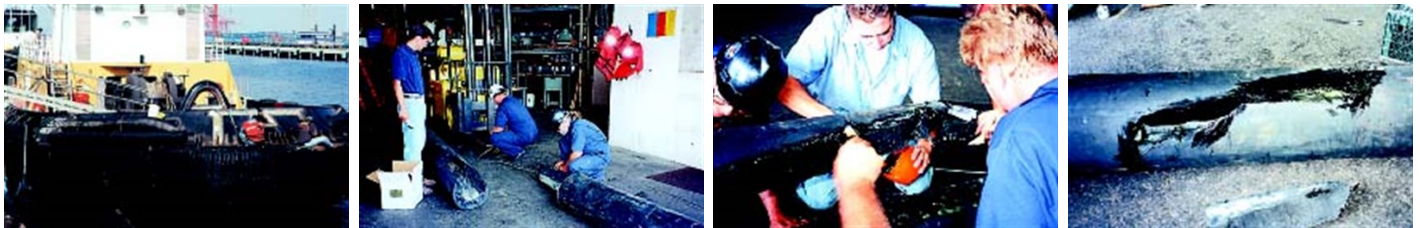
*Split rub-rail*

- \* Motor vessel projector. ,
- \* Split rub-rail. ,
- \* Applying Belzona® 2111 (D&A Hi-Build Elastomer). ,
- \* Finished application is ready for service. ,

When installed, the outer edge of the large rubber extrusion is under tension and the inner edge is under compression. During vessel assist operations, the rub rail (15,000 lbs each) split.

Application was carried out in accordance with Belzona Know-How Leaflet SOS-12.

The job was successful. Rub rails still split but not where Belzona was applied. Now they cut out the split and bond in a new section with Belzona® 2111 (D&A Hi-Build Elastomer).
