# BELZONA PROVIDES NEW LIFE FOR A BRICK FACTORY BELT

ID: 4700

Customer Location: *Brick factory, Kent, England.*  
Application Date: *September 2013*

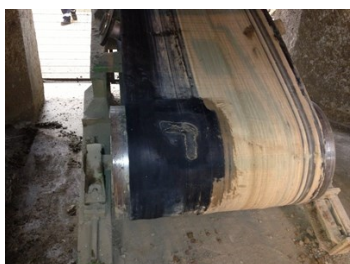
*After years of use the belt had developed a tear and clay was penetrating the layers in the belt, if the belt was to deteriorate further the factory would need to employ an unplanned shutdown.*

- \* Damaged belt prior to repair ,
- \* Cleaned and prepared with Belzona Roughing brush ,
- \* Belzona® 2311 being applied incorporating Belzona® 9341 (Reinforcement tape) ,
- \* Belt repaired and ready for years more service ,
