# COOLING WATER PIPE REBUILT AND PROTECTED WITH BELZONA

ID: 4706

Customer Location: Orange, TX

Application Date: March 2013

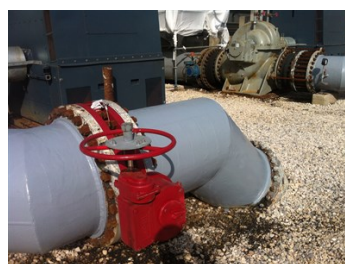
- \* Before application. ,
- \* Through-holes and pitting filled. ,
- \* Completed application. ,

Splash and spill from the nearby cooling tower caused severe pitting on the top portion of the cooling water pipes. Pipes were so thin that leaks were springing up weekly.

The application was carried out with a modified version of Belzona Know-How System Leaflet VPF-1.

Belzona had the repairs done in days, whereas replacement would have taken weeks, with a much more economical solution and a long lasting repair.
