# BELZONA PROTECTS WALLS AND FLOORS AT CIDER PLANT

ID: 4707

**Customer Location:** Cider producer, Herefordshire, UK  
**Application Date:** December 2012

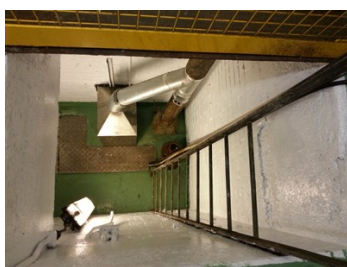
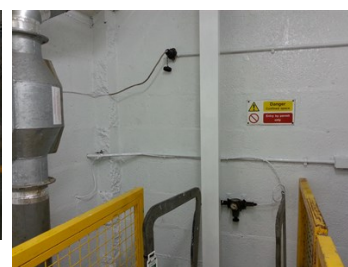
The area was un-hygenic and also needed brightening up with materials that were easy to clean. The floor also needed a safe non-slip surface.

- \* View into pit before application ,
- \* pit after application ,
- \* walls before application ,
- \* walls after application ,

A very damp and dirty pit area.

Application was carried out in accordance with Belzona Know-How System Leaflets WPA-2, FPA-1 and FPA-8. The damaged areas of the floor were rebuilt using the Belzona® 4131 before coating with Belzona® 5231. Belzona® 5111 system was applied to the walls.
