# BELZONA PROTECTS WALLS AND FLOORS AT CIDER PLANT

ID: 4707

**Customer Location:** Cider producer, Herefordshire, UK  
**Application Date:** December 2012

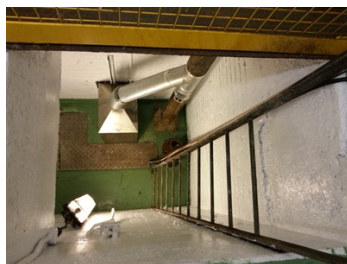
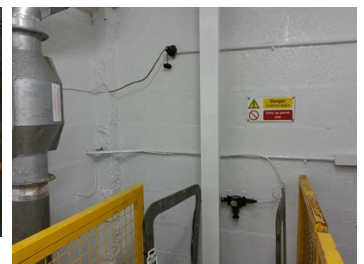
## Photograph Descriptions

- \* View into pit before application ,
- \* pit after application ,
- \* walls before application ,
- \* walls after application ,

A very damp and dirty pit area.

Application was carried out in accordance with Belzona Know-How System Leaflets WPA-2, FPA-1 and FPA-8. The damaged areas of the floor were rebuilt using the Belzona® 4131 before coating with Belzona® 5231. Belzona® 5111 system was applied to the walls.
