# BELZONA GIVES OLD PROPERTY NEW LEASE OF LIFE

ID: 4708

Application: WPA-Wall Problem Areas

Customer Location: Farm house, Worcestershire, UK

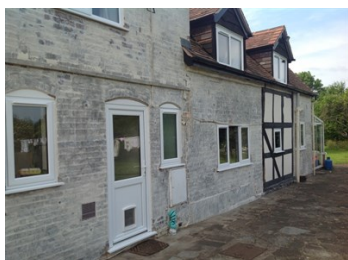
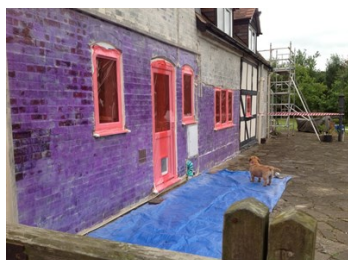
Failure of the existing paint was allowing damp to penetrate into the walls leading to further deterioration. Client needed system to protect walls and approve appearance.

- \* Surface Preparation ,
- \* Application of Belzona® 3911 (PSC Conditioner) ,
- \* Completed Belzona® 5151 Application. ,

Application was carried out in accordance with Belzona Know-How System Leaflet WPA-1. A mechanical wire brush was used over the entire surface to remove loose material. After treating with fungicidal wash the Belzona® 5151 system was applied.
