BELZONA SAVES OFFSHORE OIL & GAS PLATFORM FROM SHUTDOWN

ID: 4709

Application: VPF-Valves, Pipes and Fittings

Customer Location: Gulf of Mexico

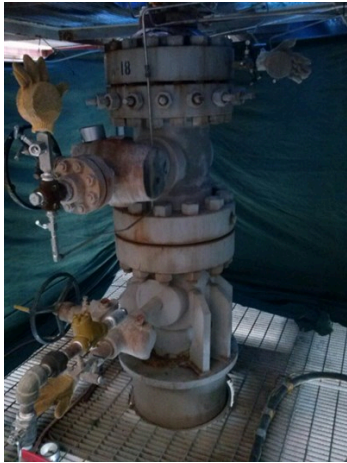
- * Photo of well conductor. ,
- * Photo identifying leak area. ,
- * Abrasive blasting in progress. ,
- * Completed Composite Wrap holding 85 PSI, no leaks. ,

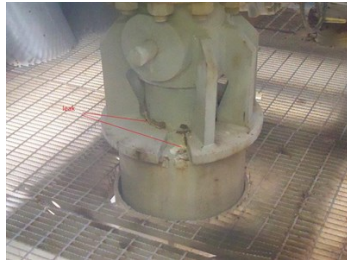
External corrosion to well conductor caused natural gas leak of 85 PSI.
