# BELZONA SAVES OFFSHORE OIL & GAS PLATFORM FROM SHUTDOWN

ID: 4709

Application: VPF-Valves, Pipes and Fittings

Customer Location: Gulf of Mexico

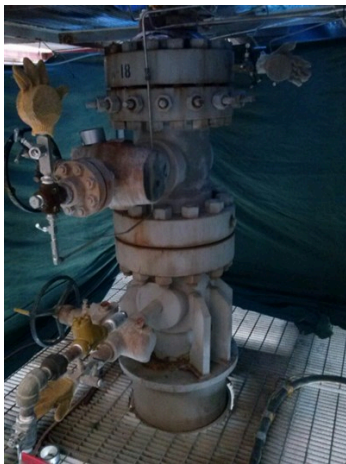
- \* Photo of well conductor. ,
- \* Photo identifying leak area. ,
- \* Abrasive blasting in progress. ,
- \* Completed Composite Wrap holding 85 PSI, no leaks. ,

External corrosion to well conductor caused natural gas leak of 85 PSI.
