BELZONA HELPS PLATFORM QUALIFYING FOR PLUG & ABANDON PROJECT

ID: 4710

Application: VPF-Valves, Pipes and Fittings

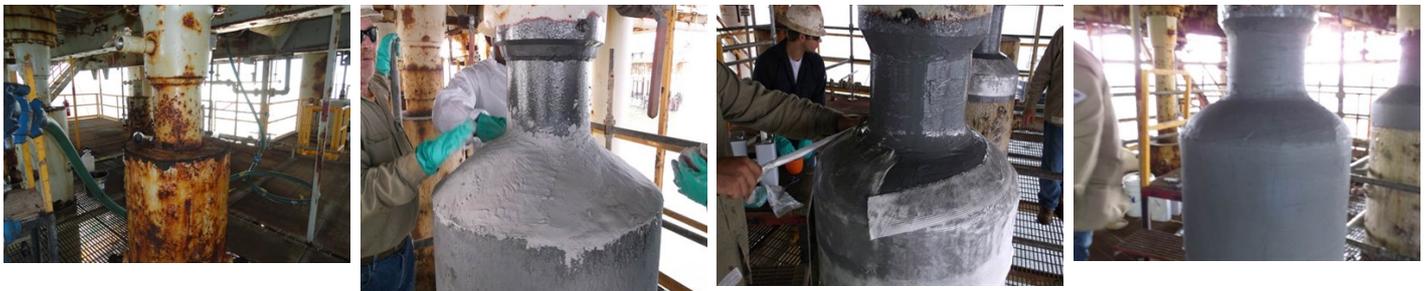
Photograph Descriptions

External/Internal corrosion caused many hole through defects. Conventional welding would have been very time consuming and expensive. Additionally, a hot work repair would have caused shut down of the platform resulting in a great loss of production and income.

- * Well conductor showing external corrosion. ,
- * Building fillet with Belzona 4141. ,
- * Installing Belzona 1121/Belzona 9371/Belzona 4151. ,
- * Completed Belzona Composite Wrap. ,

Repair was conducted in accordance with a modified version of Belzona Know-How System Leaflet VPF-1 and VPF-8. A void between the inner and outer casing was filled with concrete resulting in a sharp transition. The recommendation was to use Belzona 4141 to form a fillet for a better transition from inner and outer casing, thus ensuring a better opportunity for a successful composite wrap. After the Belzona 4141 was installed, a two layer composite wrap was applied using Belzona 1121, and Belzona 9371 wetted out

with Belzona 4151.

The alternative to a Belzona Composite Wrap solution was welding, which was very labor intensive and would have caused the platform to be shut down and degassed. The welding and loss of production would have been in the hundreds of thousand of dollars to the operator. The Belzona Composite Wrap was installed by a 4 man crew in one 12 hour shift. This included abrasive blasting and installation of the Belzona Composite Wrap.
