BELZONA SOLVES FINLOCK GUTTER ISSUES

ID: 4715

Customer Location: Housing Association, Herefordshire, UK
Application Date: March 2013

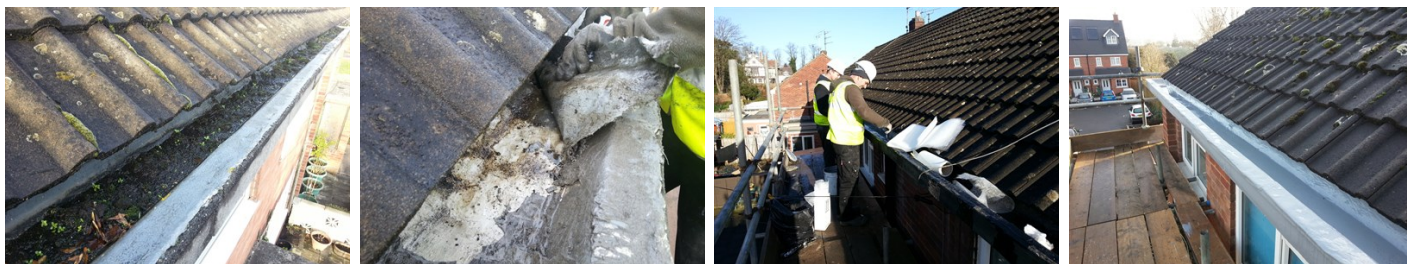
Photograph Descriptions

Finlock gutters had begun to leak into the properties.

* 1. Before Application 2. Removal of existing liners 3. Application in progress 4. Completed Application. ,

Application was carried out in accordance with Belzona Know-How System Leaflets RPA-6 and RPA-11. Any damaged areas of concrete were repaired using Belzona 4141 followed by complete coating with the reinforced Belzona 3131 system.
