# BELZONA EXTENDS VALVE BODY LIFE

**Industry:** Power  
**Application:** VPF-Valves, Pipes and Fittings  
**Substrate:** Cast Iron  
**Products:** \* Belzona® 1111 (Supermetal) ,  
\* Belzona® 2141 (ACR-Fluid Elastomer) ,

**Customer Location:** Power station, Kent, UK.  
**Application Date:** September 2013

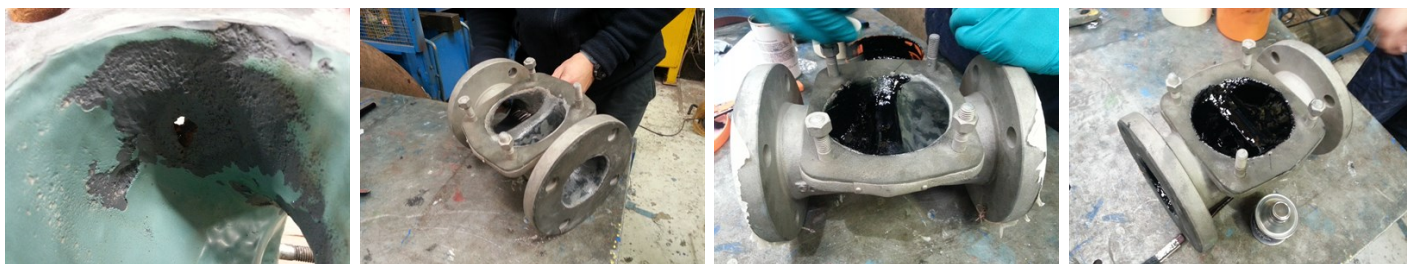
*The valve body was suffering from cavitation and would only last 4-6 weeks before breaking through the casting.*

- \* Through wall erosion damage ,
- \* Blasted and Belzona® 1111 applied ,
- \* Belzona® 2141 being applied ,
- \* Finished application ,

The valves are supplied on a regular basis and previous coating would erode very quickly and the valve body would need replacing every 4-6 weeks. Using Belzona® 2141 system the effects of the cavitation have significantly been lowered resulting in less downtime & cost savings.
