# BELZONA TAKES A GOOD HAMMERING

**Customer Location:** Foundry, Teesside, UK  
**Application Date:** 2013

2,500 tonne forging press.

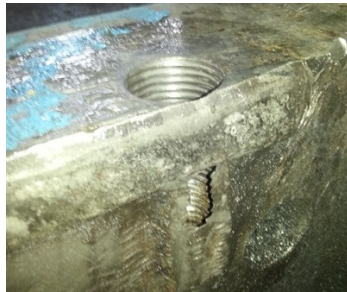
Lower bolster was not held securely due to loose fixing bolts. This led to misaligned die sets as the press hammered out parts. The movement was so severe that nearly 100% of production on this press was considered scrap and the company were considering a very expensive replacement. In addition it was found that the walls of the threads were holed and welding was impossible.

- \* 2,500 tonne press in operation ,
- \* Damage to base thread walls ,
- \* Application of Belzona® 1321 to wet out threads ,
- \* All four bolts aligned with jigs whilst material cures ,

Application was then carried out in accordance with Belzona Know-How System Leaflet ENC-2 using Belzona® 1321 after first repairing holes in side of casting by bonding plates in place with Belzona® 1221.
