# BELZONA UPGRADES DAMAGED WALLS IN PROCESS AREA

Customer Location: *Beverage producer, Herefordshire, UK*

Application: *WPA-Wall Problem Areas*

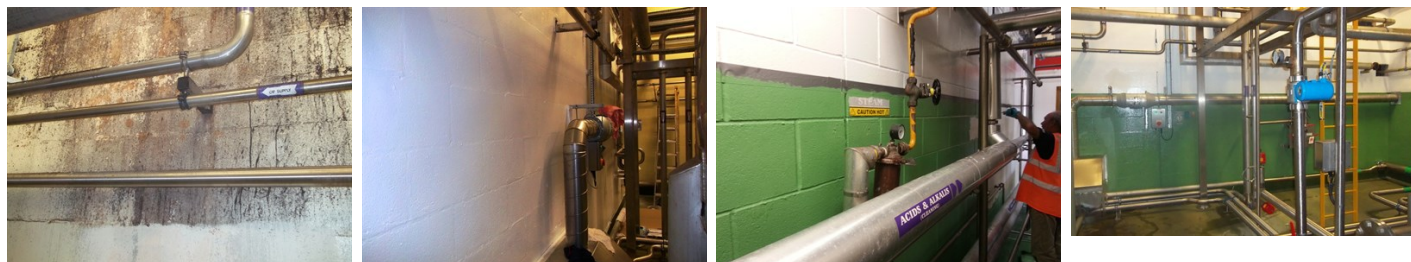
## Photograph Descriptions

*Due to chemical spills and damp conditions the walls were in need of repair and protection.*

\* 1. Damaged wall area 2. Belzona 5111 application 3. Belzona 5231 applied 4. Completed application ,

Damaged walls in process area.

Application was carried out in accordance with Belzona System Leaflet WPA-2 and WPA-4. The damaged areas of the wall were rebuilt using the Belzona 4131. Belzona 5111 system was then applied to the upper areas and Belzona 5231 to the lower areas to give the aesthetic finish required.
