# BELZONA UPGRADES DAMAGED WALLS IN PROCESS AREA

Application: WPA-Wall Problem Areas

Customer Location: Beverage producer, Herefordshire, UK

Application Date: September 2013

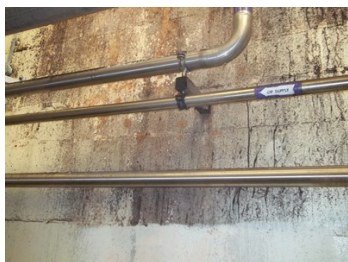
Due to chemical spills and damp conditions the walls were in need of repair and protection.

\* 1. Damaged wall area 2. Belzona 5111 application 3. Belzona 5231 applied 4. Completed application ,

Application was carried out in accordance with Belzona System Leaflet WPA-2 and WPA-4. The damaged areas of the wall were rebuilt using the Belzona 4131. Belzona 5111 system was then applied to the upper areas and Belzona 5231 to the lower areas to give the aesthetic finish required.
