BELZONA USED IN WINDMILL REFURBISHMENT

Industry: Buildings & Structures
Application: RPA-Roof Problem Areas
Substrate: Wood
Products: * Belzona 3111 (Flexible Membrane) ,

Customer Location: Windmill, Buckinghamshire, UK
Application Date: April 2013

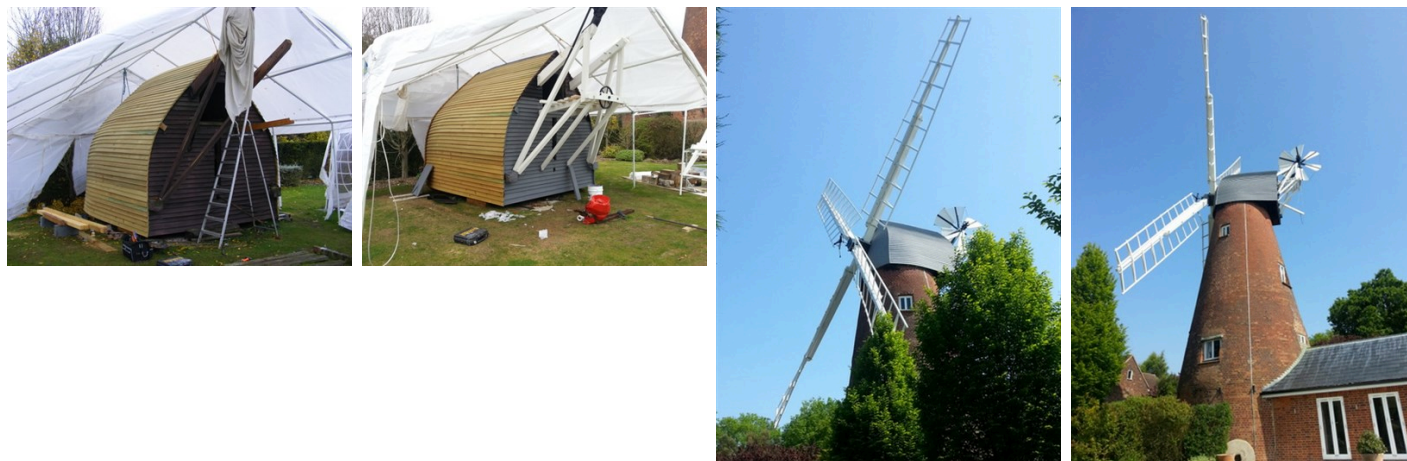
Photograph Descriptions

With the exposed nature of a windmill it was essential to provide long-term waterproofing.

- * The cap on the ground with freshly replaced timbers ,
- * First layer of Belzona 3111 being applied ,
- * & 4. Finished application with cap fitted back in place ,

Once the sails had been removed the wooden cap was taken down and work could commence to replace any rotten or damaged timber. Upon completion of the structural work the fully reinforced Belzona 3111 system was applied in accordance with Belzona System Leaflet RPA-1. With all the overlapping timbers it required the patience of a craftsman to carefully lay the reinforcing sheet into the Belzona 3111 to achieve a wrinkle free finish with the sheet closely following the substrate profile.
