# BELZONA MAKES RAMP SAFE

Industry:  
Application: FPA-Floor Problem Areas  
Substrate: Steel chequerplate.  
Products: \* Belzona® 1821 (Fluid Metal) ,

Customer Location: Local Authority, Derbyshire, UK  
Application Date: 2010

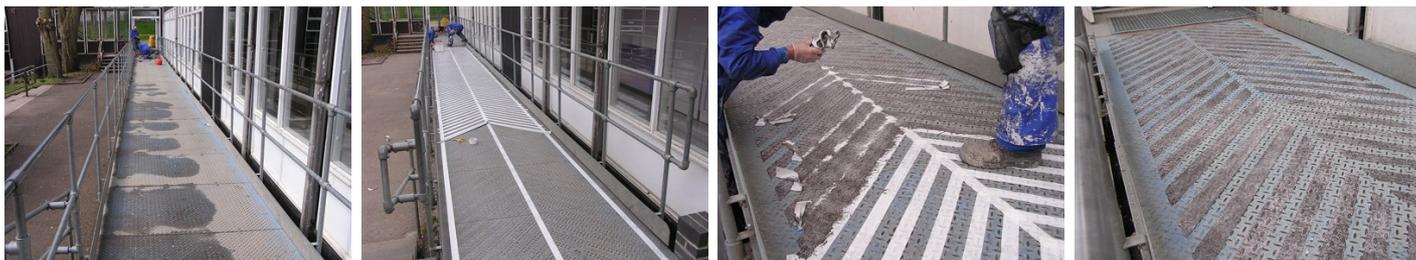
The chequerplate had become polished and slippery especially when wet.

- \* Long chequerplate walkway before application ,
- \* Chequerplate showing preparation and correct masking to provide chevron pattern ,
- \* Application by brush with immediate removal of masking tape ,
- \* Finished job ,

Application was carried out in accordance with Belzona Know-How System Leaflet FPA-8. After preparing the substrate and masking the chevron pattern on the surface the Belzona® 1821 was applied and aggregate tamped into the surface before removing the masking and allowing system to cure overnight.

Even though chequerplate is known to have a pattern across its surface this had become polished and had become very slippery especially when wet. The Belzona® 1821 grip system applied along the surface of the chequerplate provided added positive grip and safety for pedestrians.
