# BELZONA REBUILDS WORN STONE STAIRCASES BUILT IN 16TH CENTURY

ID: 4730

Customer Location: College in Cambridge, UK  
Application Date: August 2012

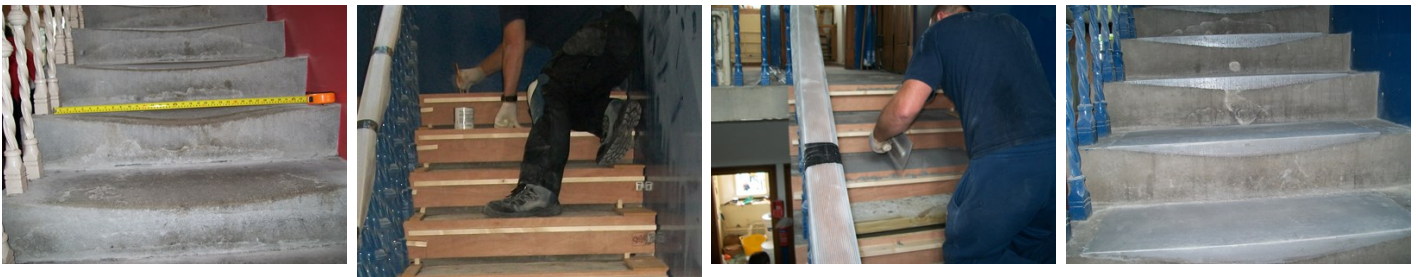
The stone steps on several staircases in this Grade 2 listed College had become badly worn over the last 500+ years of use and so were considered a Health and Safety risk. The steps had worn by up to 75mm deep in the centre, sloping towards the front so were slippery when wet. Due to the design of the stone steps it was not possible to cut out the worn area and repair in the traditional manner of inserting a new block of stone because this would weaken the staircase.

- \* Worn stone steps before, with wear up to 75mm deep in centre of step ,
- \* Wooden formers in place and Belzona 4911 being applied ,
- \* Belzona 4131 being installed with wooden former helping keep the repair flat and level ,
- \* Example of step rebuild completed with Belzona 4131 ,

Application carried out according to Belzona Know-How System Leaflet FPA-1. The top of the stone steps were abraded to create a clean surface and a wooden former system was installed to ensure the repairs were level and all to the same width (specified by the College). Belzona 4911 (TX Conditioner) was applied to prepared surface and the worn step areas were then rebuilt with Belzona 4131.
