AERATION CHANNEL LEAKS REPAIRED WITH BELZONA

ID: 4733

Customer Location: Sewage Works, Kent

Leaking joints in sewage aeration channel

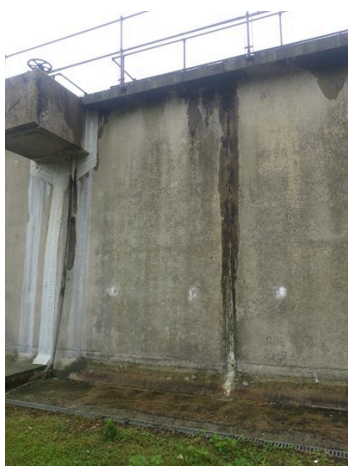
The construction and movement joints were leaking raw sewage to ground. Previous repairs were failing and only channeling the sewage in to the drains. The environment agency were threatening the customer with prosecution if the problem wasn't resolved. The lane is critical to the treatment process and could not be out of action for any length of time.

- * External view of leaking joints and previous attempts to stop leaks ,
- * Repaired Movement joint 2013 ,
- * Movement joint still going strong after revisiting in 2019 compared to alternative solution. ,
- * Movement joint still going strong after revisiting in 2019 ,

All joints were repaired in accordance with Belzona Know-How System leaflet WPA-3.

The Belzona repairs were carried out over two days and the tank was reinstated 2 days later. The aeration lane was only out of action for 5 days. After a month of being in operation there are still no leaks.

Site was revisited in 2019 showing no damage or wear on the repairs only leaks were shown on alternative solution.
