# BELZONA REFURBISHMENT OF FLAT ROOF

ID: 4742

**Application:** RPA-Roof Problem Areas

**Customer Location:** School, Grantham, UK

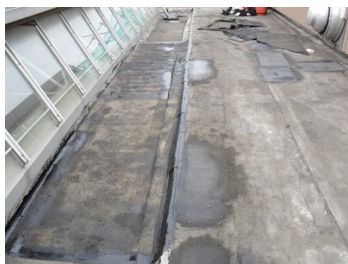
*The felt roof had deteriorated allowing numerous leaks into the areas below.*

- \* Section of roof before work started ,
- \* Completed application ,
- \* Upper section of roof before coating ,
- \* Completed application ,

Application was carried out in accordance with Belzona System Leaflets RPA-1, RPA-6 and RPA-8. After cleaning the roof and carrying out some localised repairs, a fully reinforced Belzona 3111 system was applied to the entire roof areas.
