# Belzona creates zonal floor markings

Industry: Food & Drink  
Application: FPA-Floor Problem Areas  
Substrate: Laminate flooring  
Products: \* 5231 (SG Laminate) ,

Customer Location: Glasgow, Scotland  
Application Date: February 2013

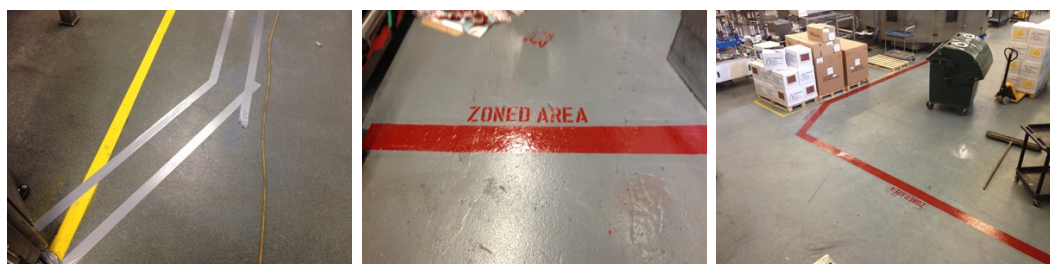
- \* Taping out area ,
- \* Zoned area ,
- \* Completed application ,

The Application was carried out in accordance with Belzona System Leaflet FPA-08. The areas were roughed with floor grinders. The desired pattern was then taped out. Two coats of 5231 were then applied. A stencil was used to denote the 'zoned area' floor marking.
