# BELZONA IMPOUNDMENT PUMP COATING SIX YEARS ON

Industry: *Marine*  
 Application: *CEP-Centrifugal Pumps*  
 Substrate: *Cast Iron*  
 Products: *\* Belzona 1341 (Supermetalgilde) ,*

Customer Location: *Port Authority, SW England*  
 Application Date: *Sept 2013*

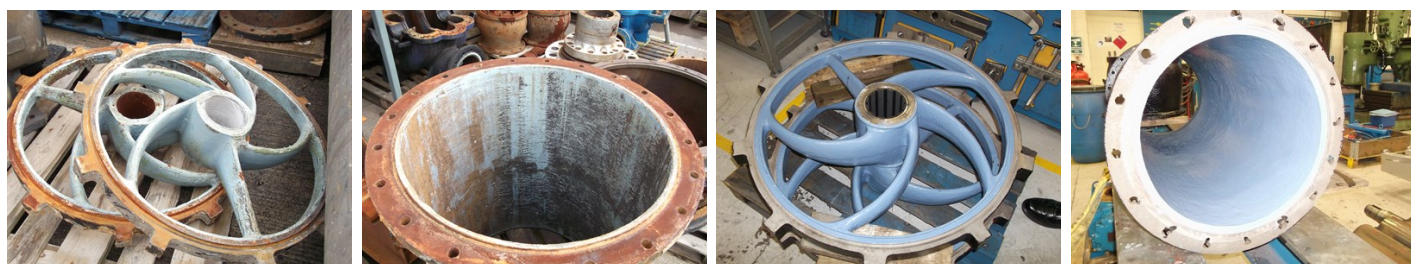
\* 1. Spider bearings after 6 years in service 2, Pump casing very little wear to the Belzona 1341 3. Spider bearings re-coated with Belzpnz 1341 4. Pump internals after coating ,

Application was carried out in accordance with Belzona Systems Leaflet CEP-10. The existing Belzona 1341 showed very little wear and small amount of build-up was cleaned by pressure washing before completing the surface preparation and re-coating with Belzona 1341.
