BELZONA REPAIRS OIL COOLERS

Application: HEX-Heat Exchangers

Customer Location: Ferronickel plant, Macedonia

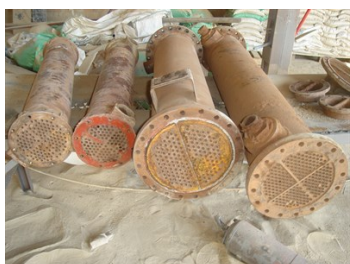
Heat exchangers were suffering from electrochemical corrosion. Gaps occurred between tube sheet and tubes and cooling water and oil started to mix.

- * Heat exchanger ready for grit blasting ,
- * The condition of end cover after blasting ,
- * End cover repaired with Belzona 1311 and protected with Belzona 1391 ,
- * Tube sheet repaired and protected ,

Application was carried out in accordance with Belzona Know-How System leaflets HEX-1 and HEX-3.
