BELZONA REPAIRS OIL COOLERS

Industry: Steel & Metal Processing
Application: HEX-Heat Exchangers
Substrate: Brass, copper and gray iron.
Products: * Belzona 1311 (Ceramic R Metal) ,
* Belzona 1391 (Ceramic HT) ,

Customer Location: Ferronickel plant, Macedonia
Application Date: August 2012

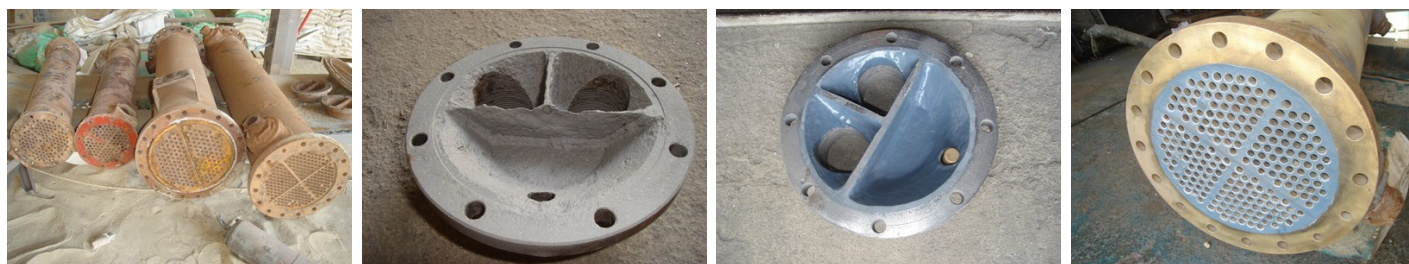
Photograph Descriptions

Heat exchangers were suffering from electrochemical corrosion. Gaps occurred between tube sheet and tubes and cooling water and oil started to mix.

- * Heat exchanger ready for grit blasting ,
- * The condition of end cover after blasting ,
- * End cover repaired with Belzona 1311 and protected with Belzona 1391 ,
- * Tube sheet repaired and protected ,

Application was carried out in accordance with Belzona Know-How System leaflets HEX-1 and HEX-3.

The customer first tried to weld the tubesheets, but was not successful. After completing repairs with Belzona the customer was very satisfied and this year a further cooler has been repaired.
