BELZONA SOLUTION FOR SPALLED VICTORIAN LINTEL

ID: 4752

Customer Location: Shoe manufacturer, South West England
Application Date: October 2013

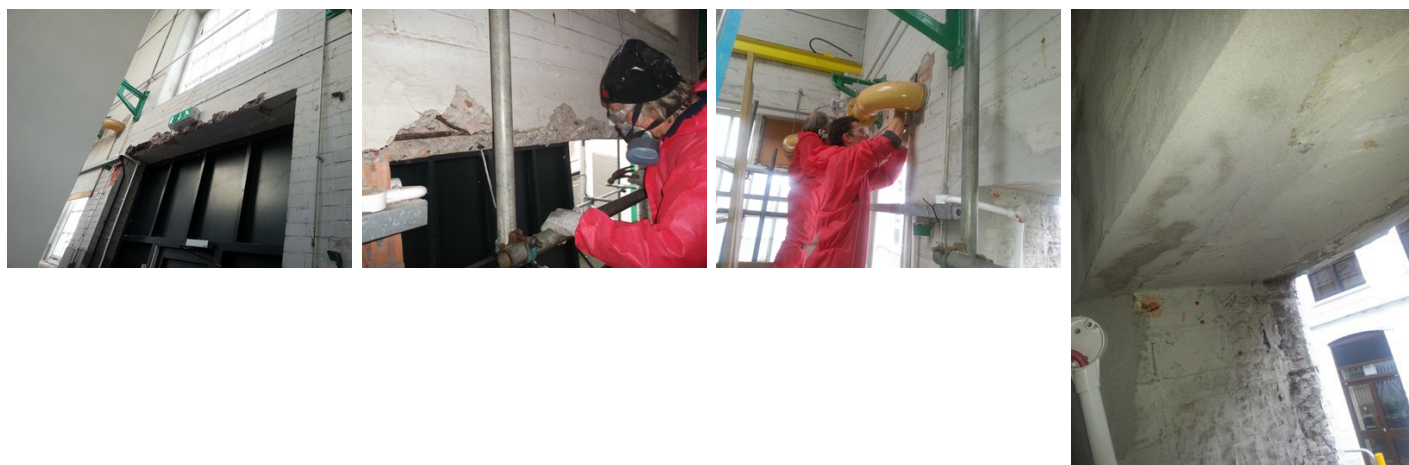
Photograph Descriptions

The lintels of the main door and windows had suffered severe deterioration. Carbonation of the concrete had allowed rebar corrosion leading to spalling of the concrete. The Belzona solution was selected due to the materials lightweight, non-porous and high adhesion together with its ability to complete the repair quickly and with minimal disturbance.

- * View of the main lintel at initial inspection ,
- * Preparation of the main lintel ,
- * Application being carried out to the adjacent window lintel showing the corner of the main lintel with the application completed ,
- * Close up of the completed application on the main lintel ,

The works were carried out in accordance with the Belzona Systems leaflet WPA-4.

Due to the age of the building and time constraints, replacement of the lintels was not an option. The Belzona solution was carried out over two days and at a fraction of the cost to replace.
