BELZONA REBUILDS WORN HOUSING

ID: 4784

Industry: *Cement*
Application: *MPT-Mechanical Power Transmission*

Customer Location: *Concrete Plant, New Brunswick, Canada*
Application Date: *August 2009*

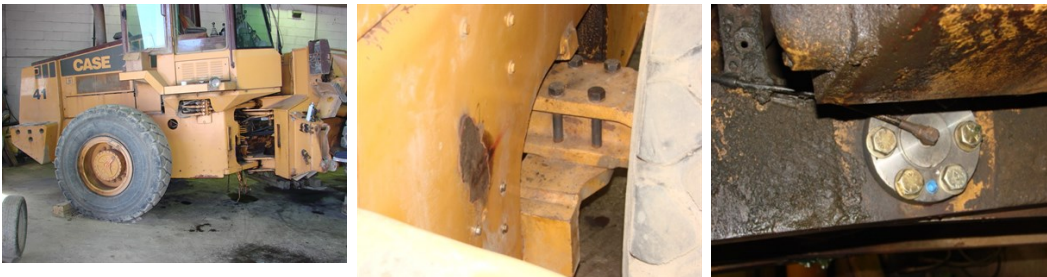
Worn pin bush housing of the loader

- * This Case front end loader had a worn bushing located in the rear walking beam. ,
- * The worn bushing was prepared with a die grinder to provide a good bonding surface ,
- * The new pin was coated with Belzona 9411 before it was reset into Belzona 1111 Super Metal. ,

Application was carried out in accordance a modified version of Belzona Know-How System Leaflet MPT-1.

Rebuilding the housing conventionally would have required the yard to dismantle the equipment and then ship it to a suitably sized machine shop for welding and line boring making for an expensive repair. This Belzona repair incurs a fraction of the downtime normally associated with these types of repairs saving enormous amount of money.
