# BELZONA REBUILDS WORN HOUSING

ID: 4784

*Worn pin bush housing of the loader*

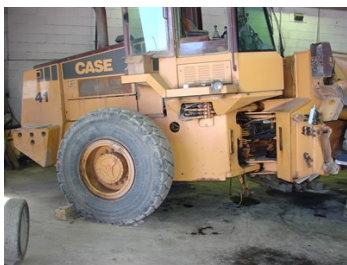
- \* This Case front end loader had a worn bushing located in the rear walking beam. ,
- \* The worn bushing was prepared with a die grinder to provide a good bonding surface ,
- \* The new pin was coated with Belzona 9411 before it was reset into Belzona 1111 Super Metal. ,
