# BELZONA REBUILDS WORN HOUSING

Customer Location: *Concrete Plant, New Brunswick, Canada*  
Application Date: *August 2009*

*Worn pin bush housing of the loader*

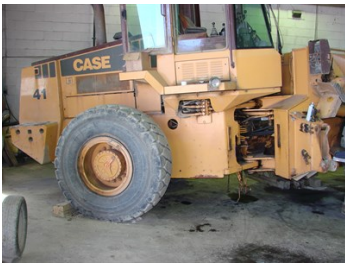
- \* This Case front end loader had a worn bushing located in the rear walking beam. ,
- \* The worn bushing was prepared with a die grinder to provide a good bonding surface ,
- \* The new pin was coated with Belzona 9411 before it was reset into Belzona 1111 Super Metal. ,
