# BELZONA PROTECTS KEEL COOLER

Industry: *Marine*  
Application: *SOS-Ships and Offshore Structures*

Customer Location: *Tug Boat Operator, BC, Canada*  
Application Date: *November 2009*

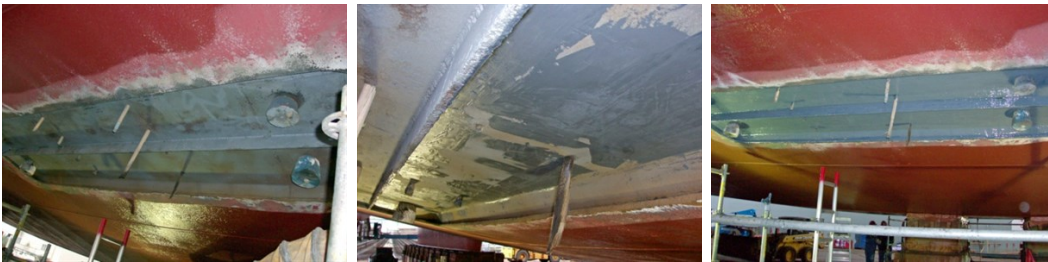
## Photograph Descriptions

*Bi-metallic corrosion was attacking the metal surfaces of the keel cooler. The metal surface had become badly pitted.*

- \* The inside of the keel cooler was showing signs of severe corrosion ,
- \* The eroded areas were rebuilt with Belzona 1311 ,
- \* Finally the entire cooler area was protected with 2 coats of Belzona 1341 ,

Keel cooler of a tug boat.

Application was carried out in accordance with a modified version of Belzona Know-How System Leaflet SOS-1.
